**REHABILITATION ALTERNATIVES REPORT**  
**FOR**  
**CEDAR SPRINGS RESERVIOR DAM OUTLET WORKS**  
**DAMID 040112**

CEDAR SPRINGS IMPROVEMENT ASSOCIATION  
PO BOX 8  
DRAKE, COLORADO 80514

GAUTHIERE ENGINEERING, INC.  
2157 BUENA VISTA DRIVE  
GREELEY, COLORADO 80634  
(970) 330-0855

JULY 23, 2013

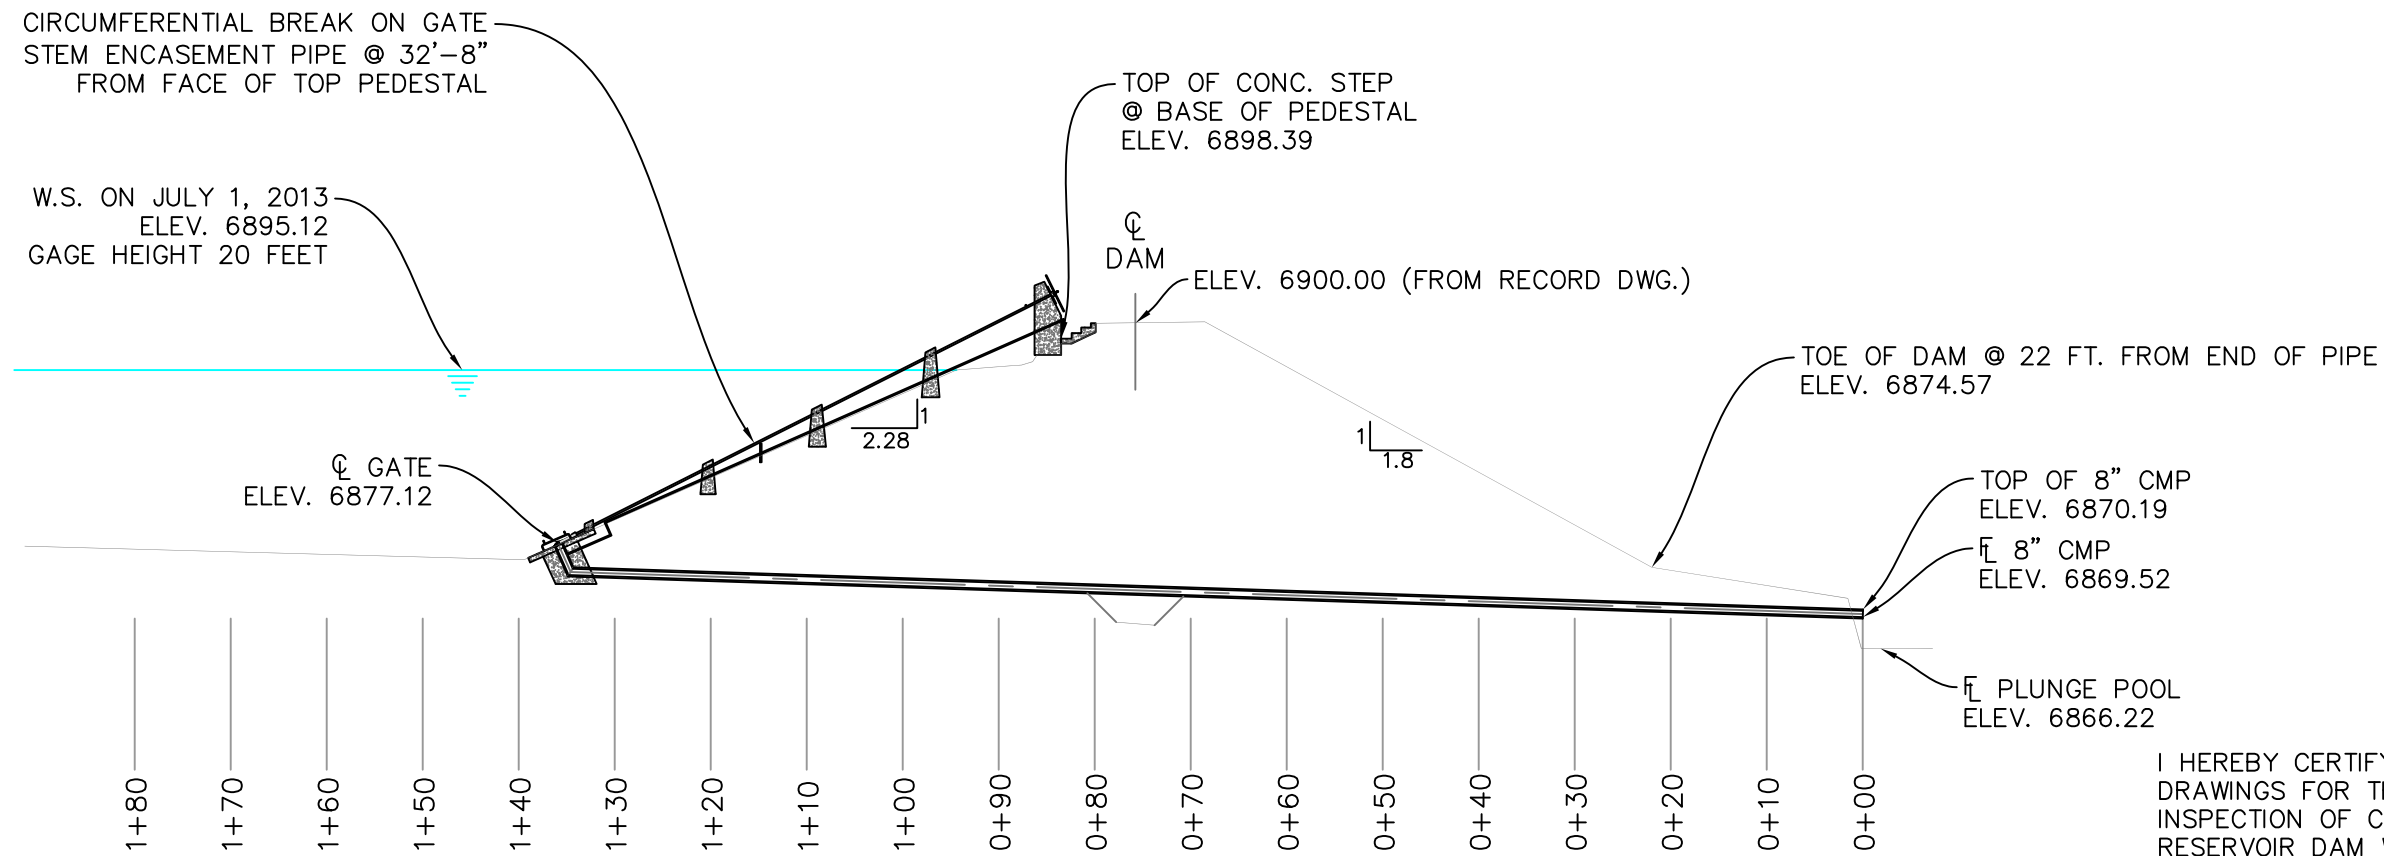
Figure No. 1 of 2

NOTE:  
 1. 8"  $\phi$  CMP OUTLET PIPE IS 135' LONG + 3' TURN UP (@ GATE) MEASURED ON JUNE 13 2013.

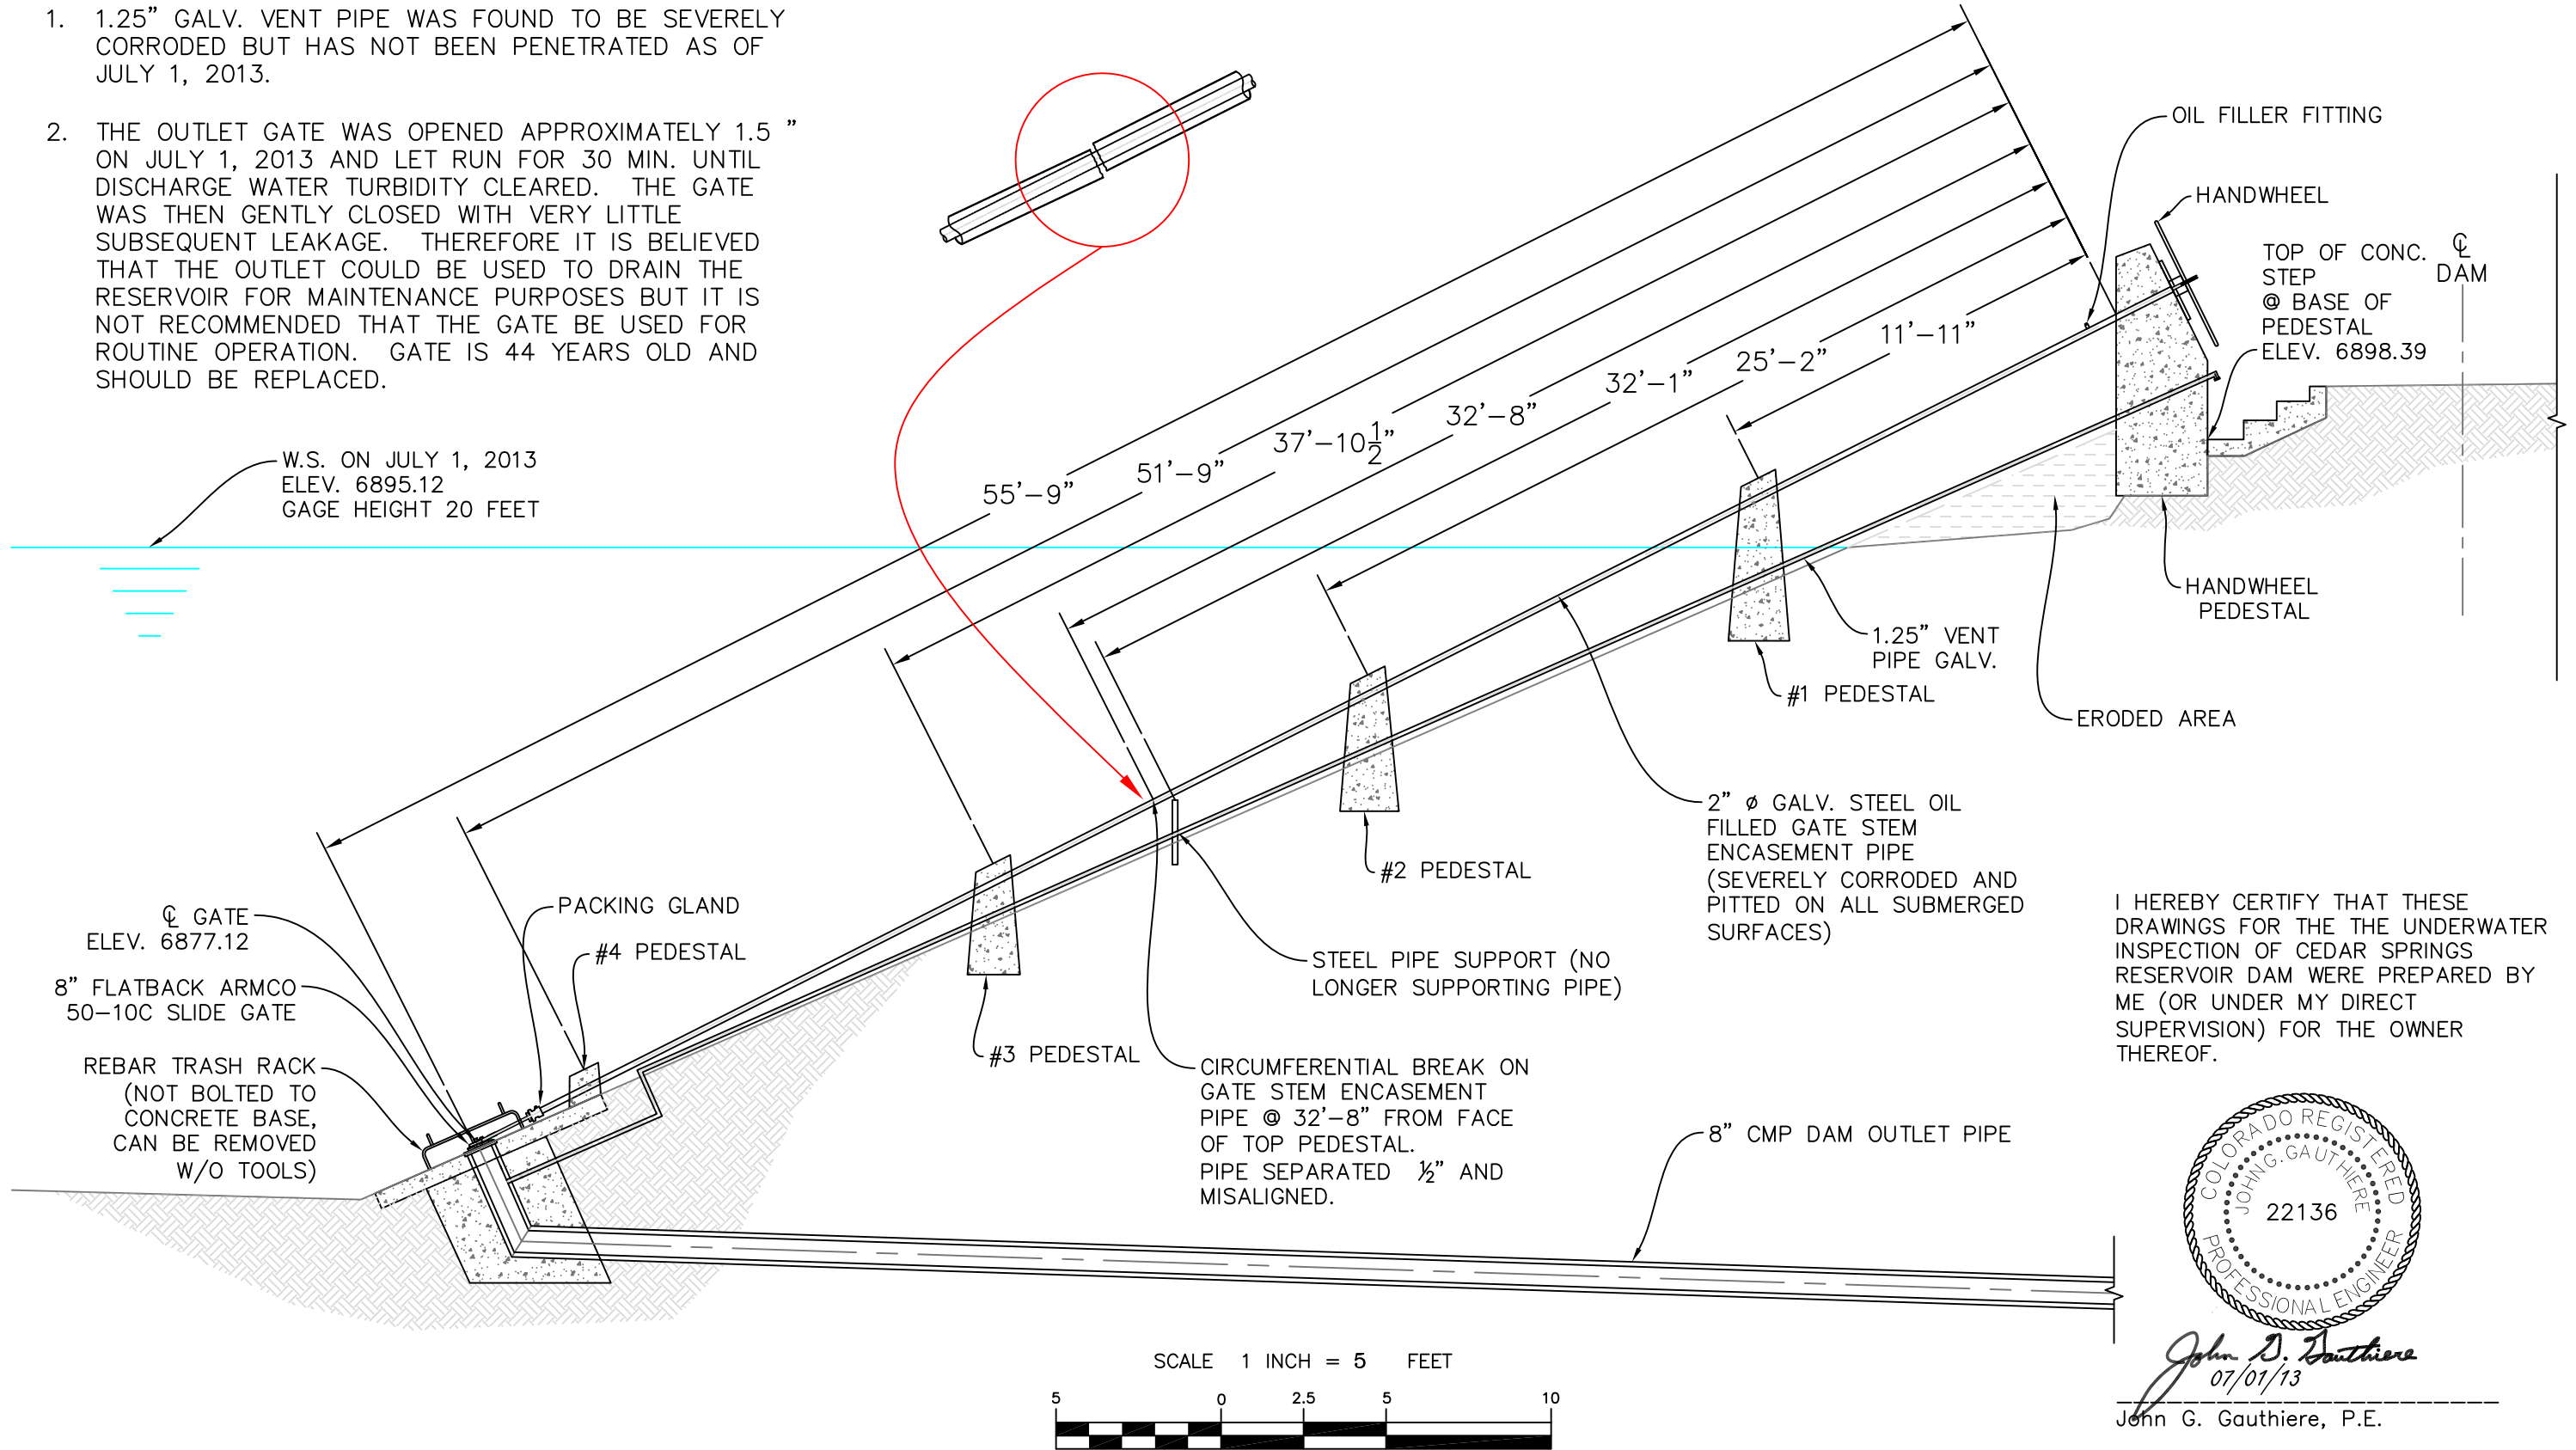
# CEDAR SPRINGS DAM DETAILS

1. 1.25" GALV. VENT PIPE WAS FOUND TO BE SEVERELY CORRODED BUT HAS NOT BEEN PENETRATED AS OF JULY 1, 2013.
2. THE OUTLET GATE WAS OPENED APPROXIMATELY 1.5" ON JULY 1, 2013 AND LET RUN FOR 30 MIN. UNTIL DISCHARGE WATER TURBIDITY CLEARED. THE GATE WAS THEN GENTLY CLOSED WITH VERY LITTLE SUBSEQUENT LEAKAGE. THEREFORE IT IS BELIEVED THAT THE OUTLET GATE COULD BE USED TO DRAIN THE RESERVOIR FOR MAINTENANCE PURPOSES BUT IT IS NOT RECOMMENDED THAT THE GATE BE USED FOR ROUTINE OPERATION. GATE IS 44 YEARS OLD AND SHOULD BE REPLACED.
